**Humayun's Tomb - Sundar Nursery - Hazrat Nizamuddin Basti
URBAN RENEWAL INITIATIVE**

HUMAYUN'S TOMB CONSERVATION

**Aga Khan Trust for Culture,
with co-funding of Sir Dorabji Tata Trust
and in partnership with the Archaeological Survey of India
undertook the conservation of Humayun's Tomb
and associated structures during 2007-2013.**

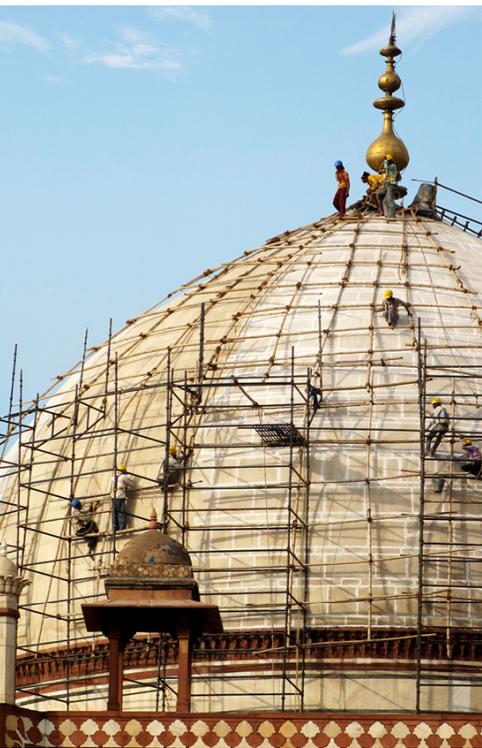
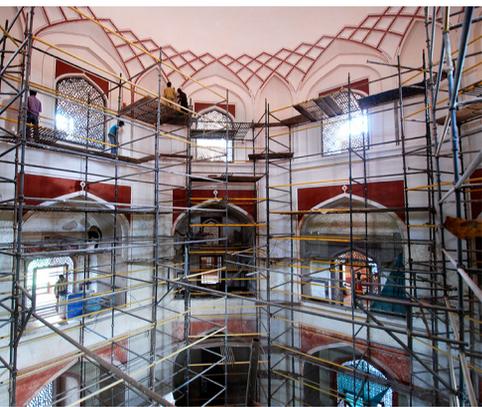
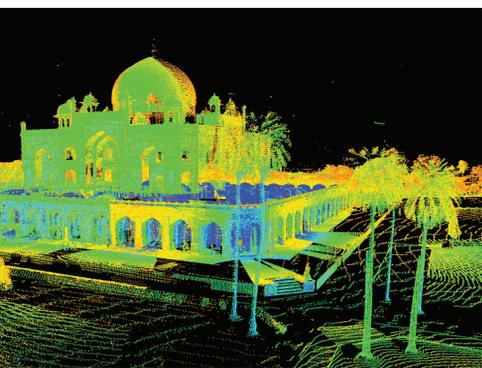
Major conservation works were required on the dome (top) and the principal tomb chamber (centre) and were preceded with a high definition survey using 3D laser scanning (bottom).

On the roof of Humayun’s Tomb, water seepage was of a primary concern. To prevent further water seepage, masons carefully filled the joints of the grand white marble dome prior to plasterers restoring the plasterwork on the inner face of the double dome. In addition, stone-carvers manually removed a million kilograms of concrete, 40 centimetres thick, from the roof in order to restore the original levels and reveal buried architectural elements.

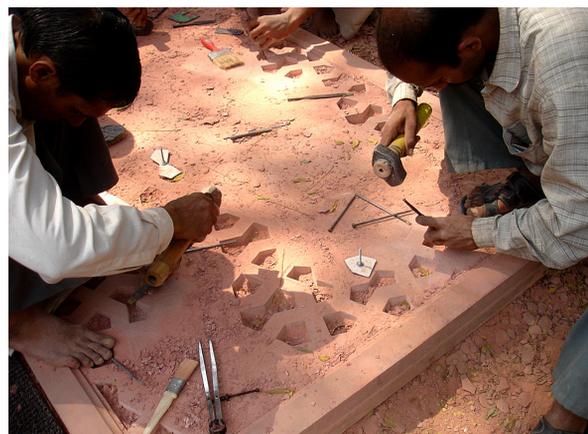
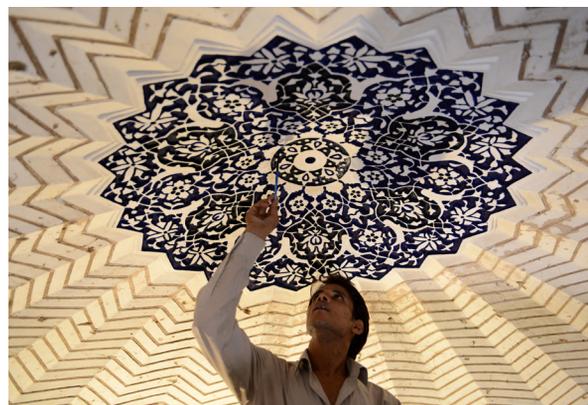
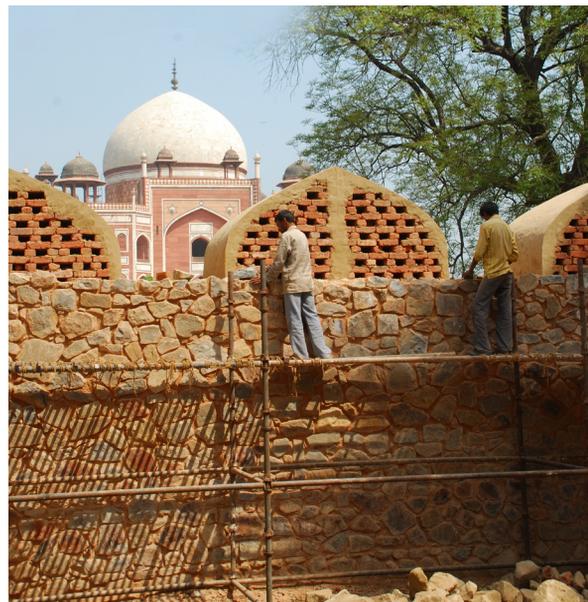
Stone carvers (top), plasterers (central) and masons (bottom picture) used traditional materials building techniques and tools to restore the intention of the Mughal builders

The contrasting red-white surfaces of the mausoleum, achieved by the use of red sandstone with white marble inlay, is the defining architectural element of the Tomb. Each stone of the facade was scientifically analysed to determine the most appropriate strategy: repair or replacement. Stone-carvers used traditional hand tools to match the original finish of the stone; similarly masons also used traditional building techniques to reconstruct the 42 arched recesses of the garden enclosure wall that had collapsed in the 20th century.

The use of cement during 20th century interventions altered the significance of many structures in the complex. Cement plaster as much as 15 centimetres thick that was causing significant damage to the stone masonry had to be painstakingly removed from the Northern and Eastern pavilions, the walls of the Western and Southern gateways, and on the ground level facade of the Mausoleum. To restore these structures, over 20,000 square metres (225,000 square feet) of wall and ceiling surfaces was re-plastered using lime mortar, prepared in a lime wheel with additives such as molasses, egg white, fruit pulp or marble dust. Lime plaster, applied in layers, with the final layer being one millimetre thick, and used by the Mughals to mimic white marble.

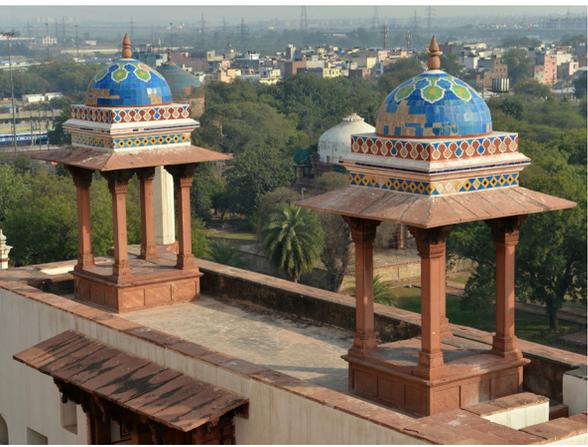
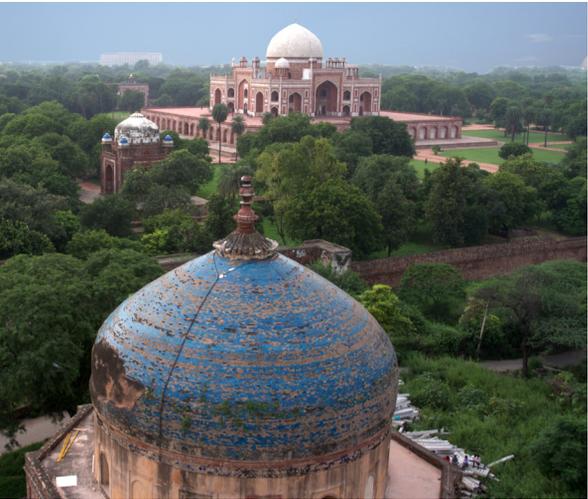
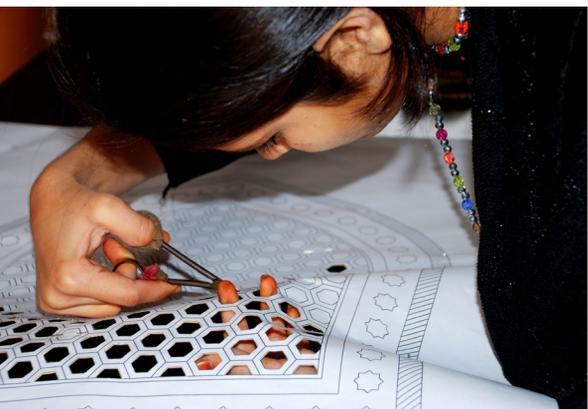
Restoration of tilework at Humayun's Tomb (top) required four years of experimentation. The skills acquired by local youth will be used to restore tile work on all monuments that stand in the setting of Humayun's Tomb, such as Nila Gumbad (centre). Youth and women groups have been trained in diverse skills ranging from computer operations to paper cutting (bottom picture) to create economic opportunities

For the Mughal builders, the tiles on the roof canopies represented a reminder of their Persian ancestry. In the 21st century, however, the tiles represented a craft skill lost in India. The conservation process required four years of experimentation, which was started under the guidance of master craftsmen from Uzbekistan – who trained youth from the adjoining Nizamuddin Basti in tile making.
